Mark Toppo's '50s phono with VM record changer

NEW MEXICO

RADIO COLLECTORS CLUB

Resistor Line Cords Revisited by Ed Brady

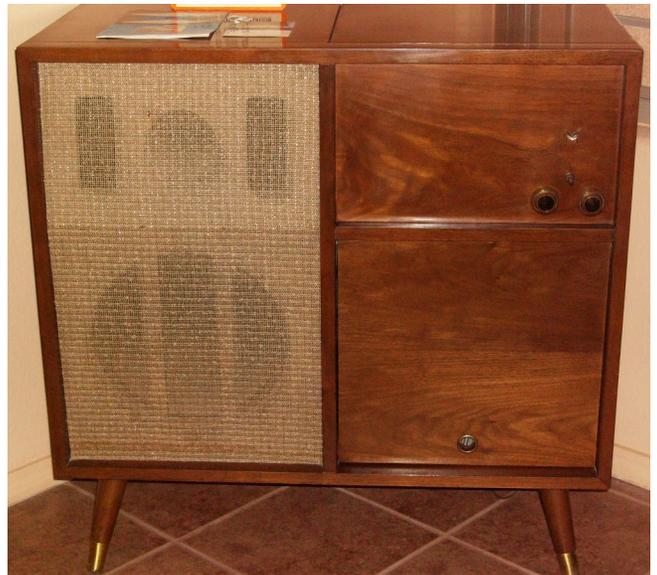
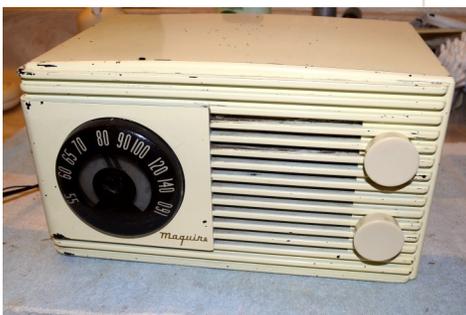
Maguire 561DI AM Table Radio with "DNA HELIX" tuning mechanism

Typical compact 5-tube All-American superheterodyne but with rather interesting inductive tuning mechanism. The dial cord drives a pulley connected to the dial pointer disc and the end of an intertwined pair of brass rods. Spring-clipped into holes in the hexagonal-shaped sleeve are two 3/16 inch

steel balls (one cannot be seen 180 degrees around the rear). These balls ride in the "trough" formed by the spiral and cause the sleeve and the attached tuning slugs to move laterally when the spiral is axially rotated. The slope of the spiral was chosen to permit a greater-than-180-degree swing of the tuning pointer, not ordinarily possible with a pointer directly attached to a typical variable capacitor shaft. Of course the same effect could be accomplished with a complex dial cord arrangement, but that would require more parts, more labor-intensive assembly, and more of a servicer's nightmare. This arrangement permits the dial numbering to be more spread out, and thus easier to read and tune.

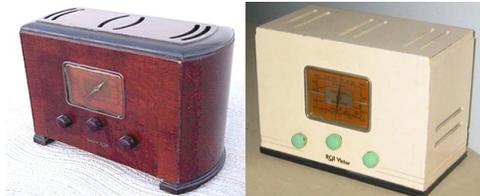
A few weeks ago I received an email from a good friend that was trying to restore several RCA 5X radios but was having trouble with one of them. They were all basically working but once of the radios was drawing about 200mA more current than it should. The RCA Model 5X is a compact five tube AC-DC super-heterodyne radio. There were three cabinet variants; 5X, 5X3 and 5X4. Of the three, the 5X model is my favorite.

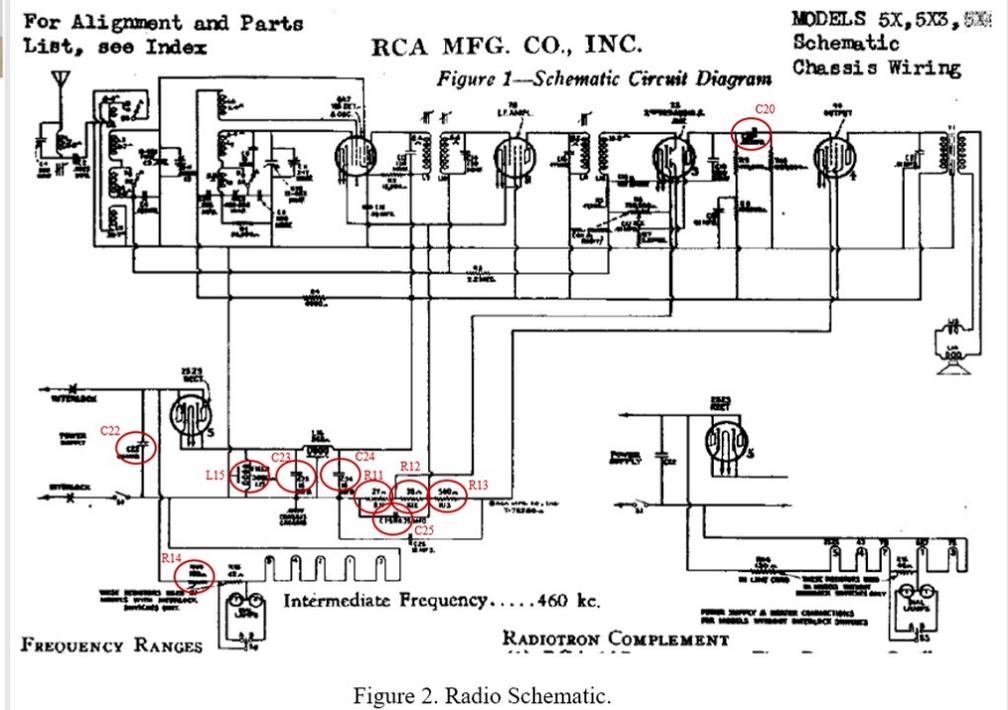
Since my friend lives on the east coast and I in New Mexico, I could not just go visit him and help trouble shoot the set. To help him I was going to have to rely on emails and phone calls which is not the best way to trouble shoot a problem radio. Figure 2 shows the schematic for the radio. Common reasons for excessive current in a set include wiring problems, leaky capacitors, shorted speaker field coil, shorted tube elements or out of tolerance resistors. After reviewing the schematics, my top prospects for the problem included C20, C22, C23, C24, C25, R11, R12, R13, R14, and L15; circled red in the schematics. C22 is directly across the power mains. These capacitors are notorious for going bad and should always be replaced. However its leakage resistance would need to be less than 1Kohms to cause the current problem the radio is exhibiting. With a leakage resistance that low, the cap would probably fail quickly. It may be a contributor to the problem but it's not the root cause. C23 and C24 are the high voltage filter capacitors. As with C22 they are leading candidates for leakage problems, but they would need to have a leakage resistance of less than 1Kohm to cause the excess current problem the radio is exhibiting. Again needs to be checked but not root cause. L15 is the speaker field coil and is connected from the high voltage plate supply to ground. It has a 3Kohm resistance and is not likely the problem as 2/3 or more of the coil windings would need to short to cause

a current increase being exhibited by the set. R14 is in series with the tube filaments and is used to drop the difference in voltage from the power mains and the series-stacked tube filament voltages. If this resistance is too small it will cause an increase in the input current. But if it were incorrectly sized to increase the set current by almost 200mA odds are one of the tube filaments would burn out as this would represent a 1.7x increase in filament current. It could be a contributor but again not the root cause. C20 is the grid coupling capacitor to the 43 tube. Just a few micro-amps of

across the resistor which raises the cathode to a voltage above ground. With the grid at or near ground the resulting grid-to-cathode voltage is negative. If the value of the resistors decreases or becomes shorted, or the capacitor becomes leaky the tube's cathode bias voltage will be reduced. This will reduce the negative bias on all the tubes thus allowing more plate current to flow. Since this circuit impacts all the tubes at once they all will contribute to the excess current flow without significantly impacting any given element. In my opinion this is the likely culprit of the problem.

leakage current can more than double the plate current of the tube. This current can be caused by a leakage as low as a few mega-ohms so it is a highly likely candidate. Again probably not the root cause as having that much excessive current flow through the tube would cause the plate to turn red. C25, R11, R12 and R13 form the self-biasing network for all the tubes. This circuit is used to create a negative bias on the tube by placing a positive voltage on each tube's cathode. The negative grid bias is a result of biasing the cathode at a higher voltage than the grid. This circuit creates the bias by inserting a resistance in series with the cathode. Current flowing through the tube creates a voltage drop

I emailed my friend and told him what to check. He had already replaced all the capacitors and all the other components checked out ok. But in checking these components, he found that someone had shorted the cathode of the 6A7 and 78 tube to ground. This effectively shorts out R11 and R12 in the cathode self-biasing circuit. This changes the bias to all the tubes, decreases the negative grid voltage, and allows excess plate current to flow. With the short removed, the radio operated normally and within the current limits; as specified by the manufacturer. But the radios still were not operating properly. Now every time he turned on one of these sets, the pilot light would burn out.
